Manhole Inspection Summary

Manhole # S65I__005MH

Insp Date: **6/3/08 11:25 AM**

Location Address: **5900 Eastern Ave.**

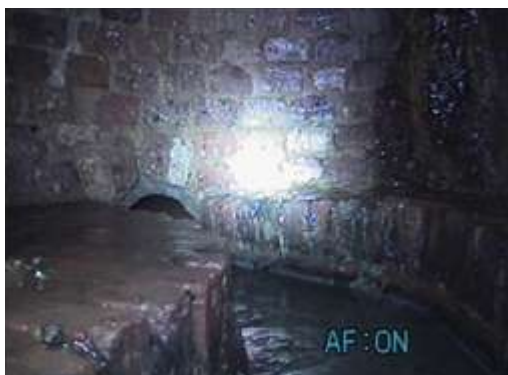
Defect 3

Infiltration on barrel wall to the right of the outgoing pipe

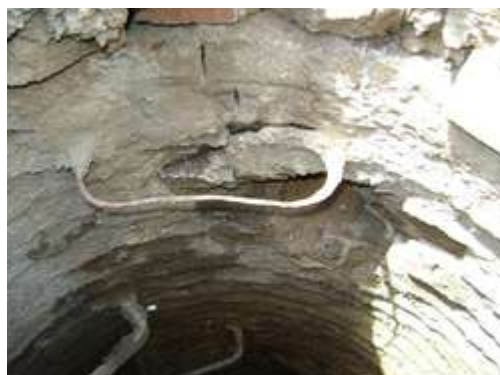
Defect 1

Condition: ☐ Sound ☐ Cracked ☐ Root Intrusion ☒ **Loose Brick** ☒ **Deteriorated**

Infiltration: ☐ None ☒ **Joint** ☐ Cracks ☒ **Mortar** ☐ Roots ☐ Wall

cracks in mortar in chimney

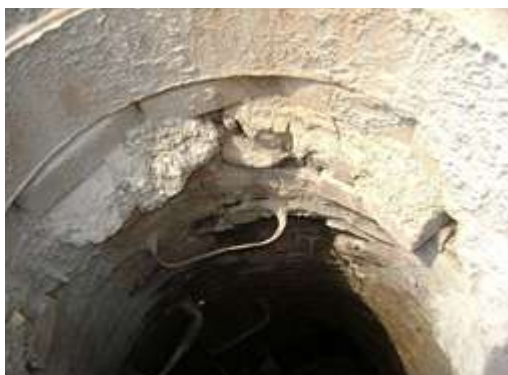
Defect 2

Infiltration: ☐ None ☐ Joint ☐ Cracks ☒ **Mortar** ☐ Roots ☐ Wall

infiltration in barrel

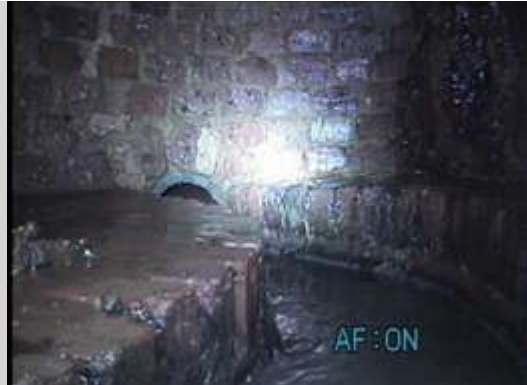
12 O'Clock Outflow

10 in. Circular Gravity Sewer
Pipe Out @ 12 O'Clock

Pipe Height: **9.6** (in.) Rod and Bar (Angled)
Pipe Material: **Clay** ☐ Pipe Lined
Invert Depth: **11.50** (ft.) Flow Characteristics: **Slow**
Deposits: ☒ None ☐ Mud ☐ Sludge ☐ Debris ☐ Grease
Silt Depth: (in.) Deposits Extent:
Infiltration: **None** Pipe Seal Cond: **Sound**

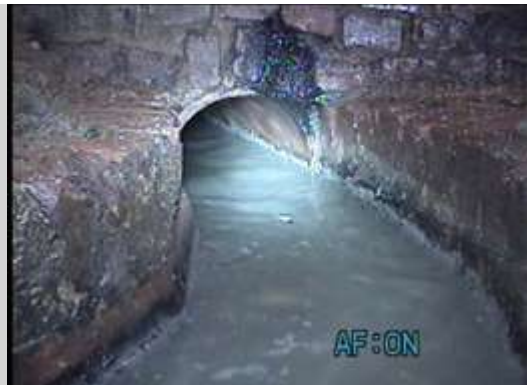
3 O'Clock Inflow

10 in. Circular Gravity Sewer
Pipe In @ 3 O'Clock

Pipe Height: **9.6** (in.) Rod and Bar (Angled)
Pipe Material: **Clay** ☐ Pipe Lined
Invert Depth: **11.33** (ft.) Flow Characteristics: **Slow**
Deposits: ☒ None ☐ Mud ☐ Sludge ☐ Debris ☐ Grease
Silt Depth: (in.) Deposits Extent:
Infiltration: **None** Pipe Seal Cond: **Sound**
